# RAIB issues report into collision between road-rail vehicles near Ramsden Bellhouse

September 1, 2022

RAIB has released its report into a collision between road-rail vehicles (RRVs) which occurred near Ramsden Bellhouse, Essex, just before 0700 on 2 May 2021.

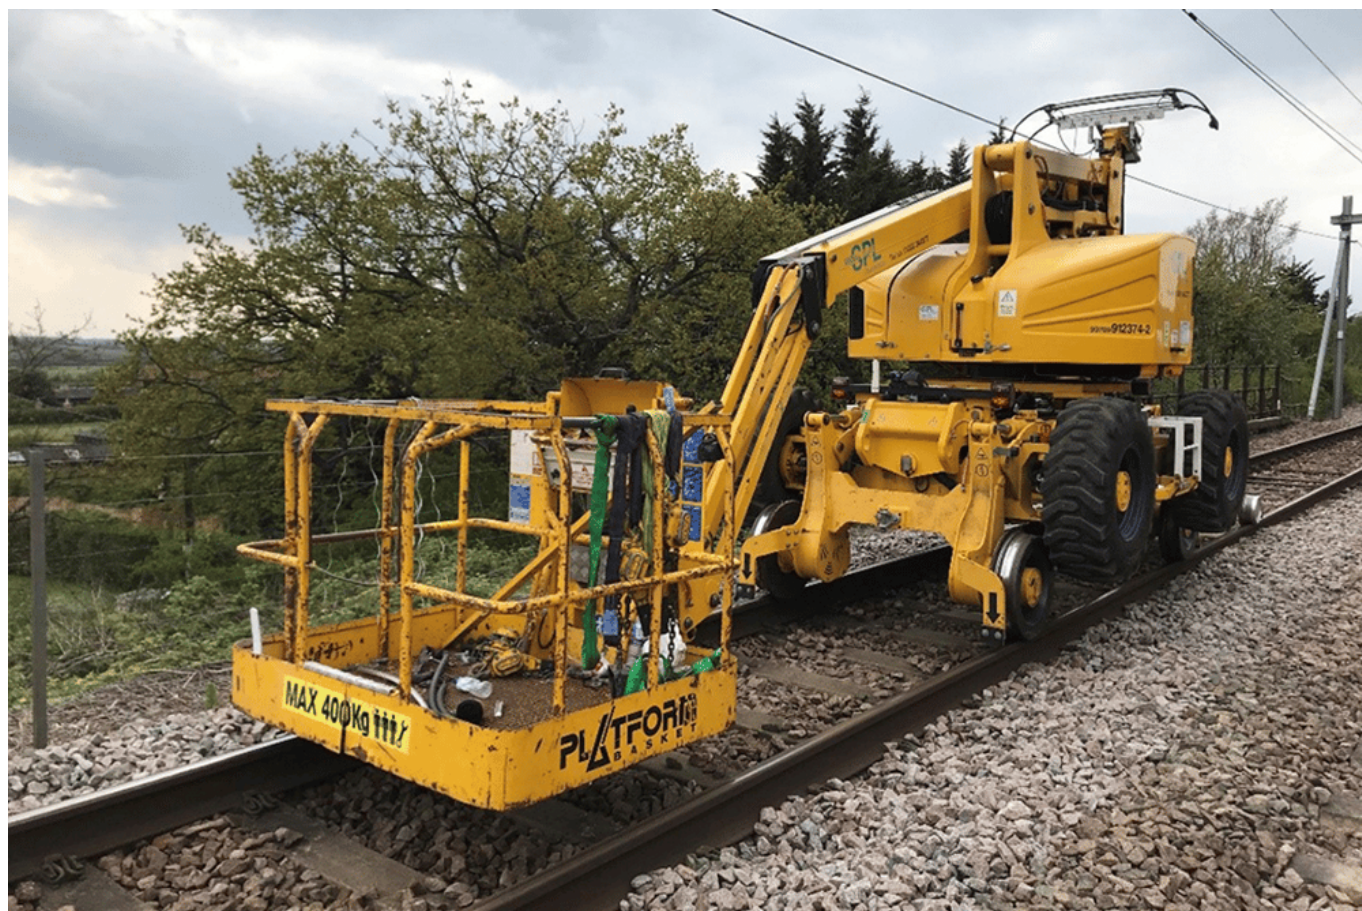
The leading vehicle, a mobile elevating work platform (MEWP), was stationary at the time of the collision and was hit from behind at around 7.5 mph (12 km/h) by a road-rail machine, configured as a crane. The MEWP operator suffered life-changing injuries due to the collision.

Around 10 seconds before the collision, the MEWP operator had stopped to stow away a tool which was loose in the personnel basket of his machine. Around the same time, the operator of the crane became dazzled by the rising sun ahead. The crane operator turned to look out of the side window to relieve his eyes but did not apply the brakes of the crane when he did so, resulting in the collision with the MEWP.
