# RAIB Report: Collision between passenger trains at Salisbury Tunnel Junction

October 25, 2023

RAIB has released its report into a collision between passenger trains at Salisbury Tunnel Junction, Wiltshire, 31 October 2021.

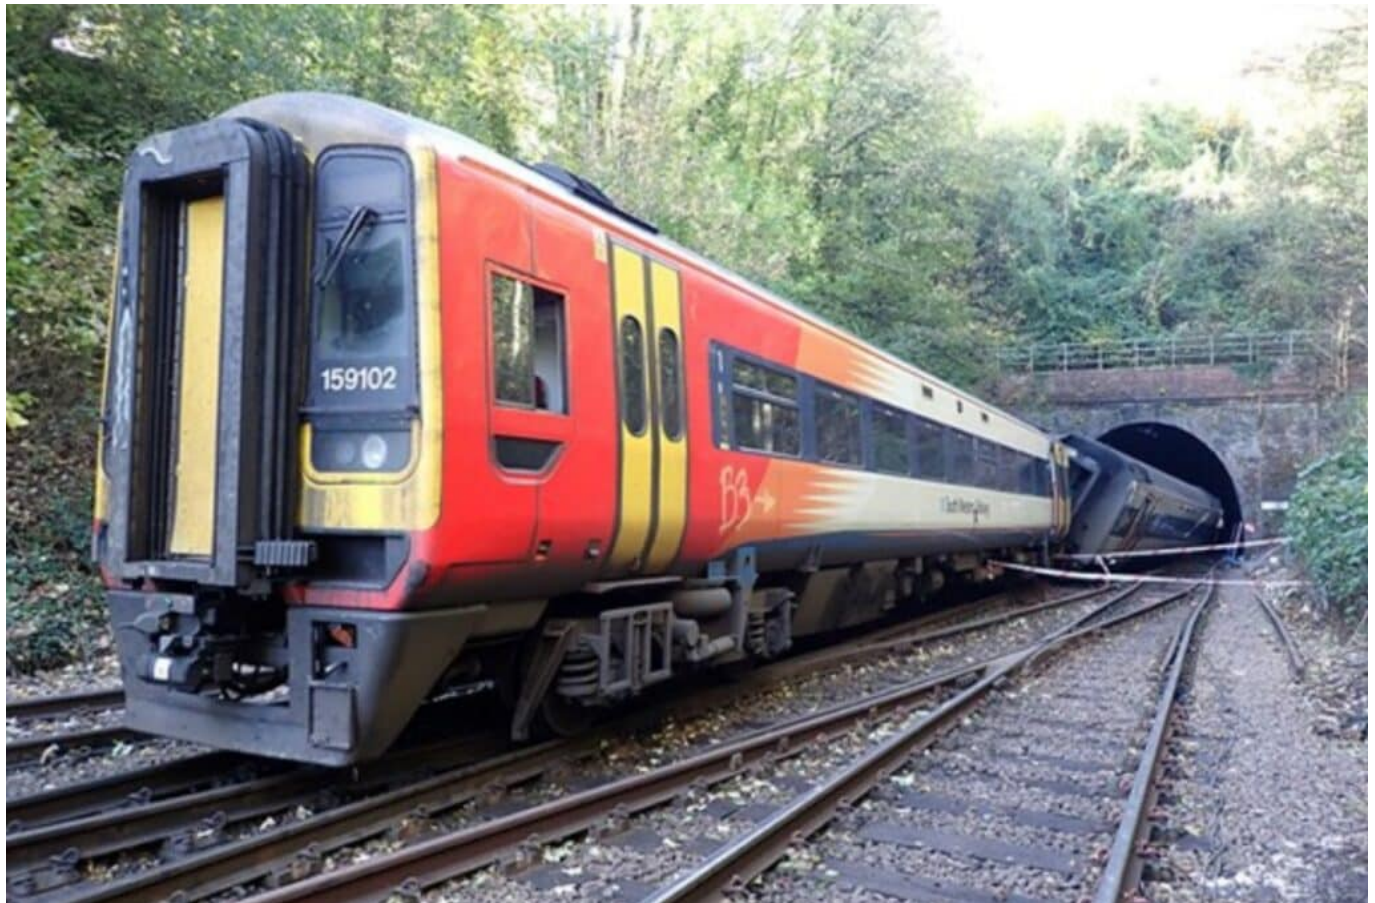
The impact of the collision caused the front two carriages of train 1L53 and the rear two carriages of train 1F30 to derail. Both trains continued some distance into Fisherton Tunnel before they came to a stop. Thirteen passengers and one member of railway staff required treatment in hospital as a result of the accident, which also caused significant damage to the trains and railway infrastructure involved. A
