RAIB Report: derailment of a tram at Bulwell

March 27, 2024

The [Rail Accident Investigation Branch \(RAIB\)](#) has released a report into the derailment of a tram at Bulwell, Nottingham, on 12 June 2023.

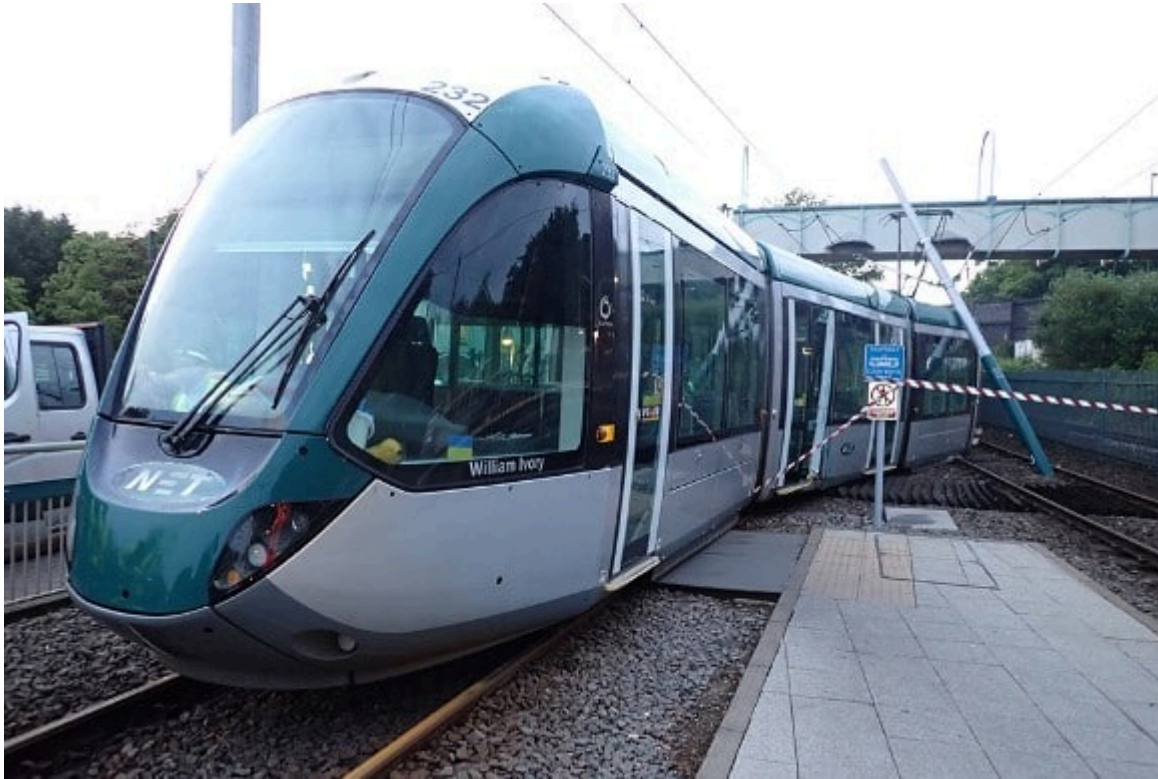
At around 17:06 hours, a southbound tram, travelling at around 41 km/h (25 mph), approached a set of facing points in an unsafe condition at the north end of Bulwell tram stop in Nottingham. As it travelled over the points, the first and second bogies of the tram were routed in different directions and the tram subsequently derailed.

During the derailment, the tram struck a pole that supported overhead line equipment causing a pane of glass to dislodge and strike a passenger, resulting in minor injuries. The driver of the tram also suffered a minor injury. Significant damage was caused to the tram and infrastructure, with the line reopening on 23 June following extensive repairs.

The set of spring-loaded points were in an unsafe position because they had not reset correctly after the passage of the previous two northbound trams. This can sometimes happen in normal working conditions, but the risk of this happening at the time of the accident had possibly been increased due to the environmental conditions causing the slide plates to be dry or contaminated.

RAIB has made three recommendations, all addressed to Nottingham Trams Limited. The first recommends a review of control room policy and procedures to ensure that clear and practical guidance is available to manage the response to engineering faults. The second recommendation relates to the improvement of risk assessments in light of this accident. The third recommendation concerns the consideration of human factors when assessing the effects of a proposed engineering change.
