RAIB Report: Freight train derailment at Sheffield station

October 5, 2021

The Rail Accident Investigation Branch (RAIB) has released its report into a freight train derailment at Sheffield station, 11 November 2020.

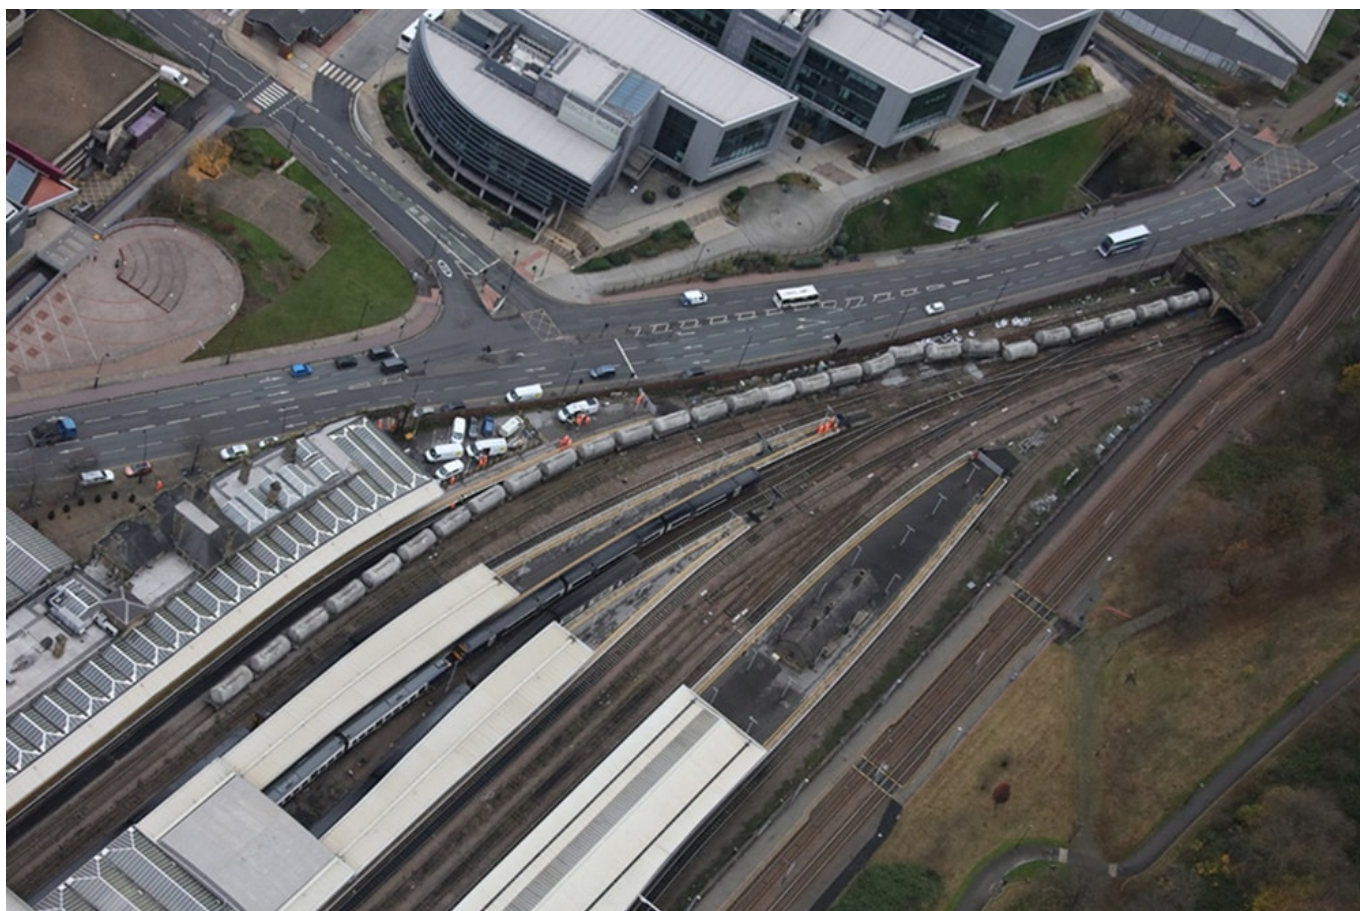
At 02:44 hrs on Wednesday 11 November 2020, 16 wagons of a freight train that was conveying cement powder from Hope, Derbyshire, to Dewsbury, West Yorkshire, derailed at the north end of Sheffield station. A number of wagons were damaged and there was significant damage to the track, resulting in a partial closure of the station. No one was injured.

The train was coasting through the station at a constant speed of around 12 mph (19 km/h) when the leading right-hand wheel of the twelfth wagon dropped into the space between the two running rails, because the rails were too far apart: a problem known as gauge widening. The train stopped when the signaller observed a number of signalling equipment failures indicated on a display screen, and alerted the driver to a problem.

The track gauge had widened because a number of track screws, that secured the rails and baseplates to the wooden bearers, had broken, allowing the rails to spread apart under the loads from passing trains.

The track screws had failed several weeks, or perhaps months, before the derailment, but the failures had not been identified by Network Rail's maintenance inspection activities.

RAIB has made four recommendations to Network Rail concerning the implementation of processes for identifying high derailment risk locations, the implementation of safety-critical changes to its processes, standards governing fitment of check rails, and track geometry data formats.
