# RAIB on buffer collision: driver was distracted by mobile phone and falling bag

August 11, 2022

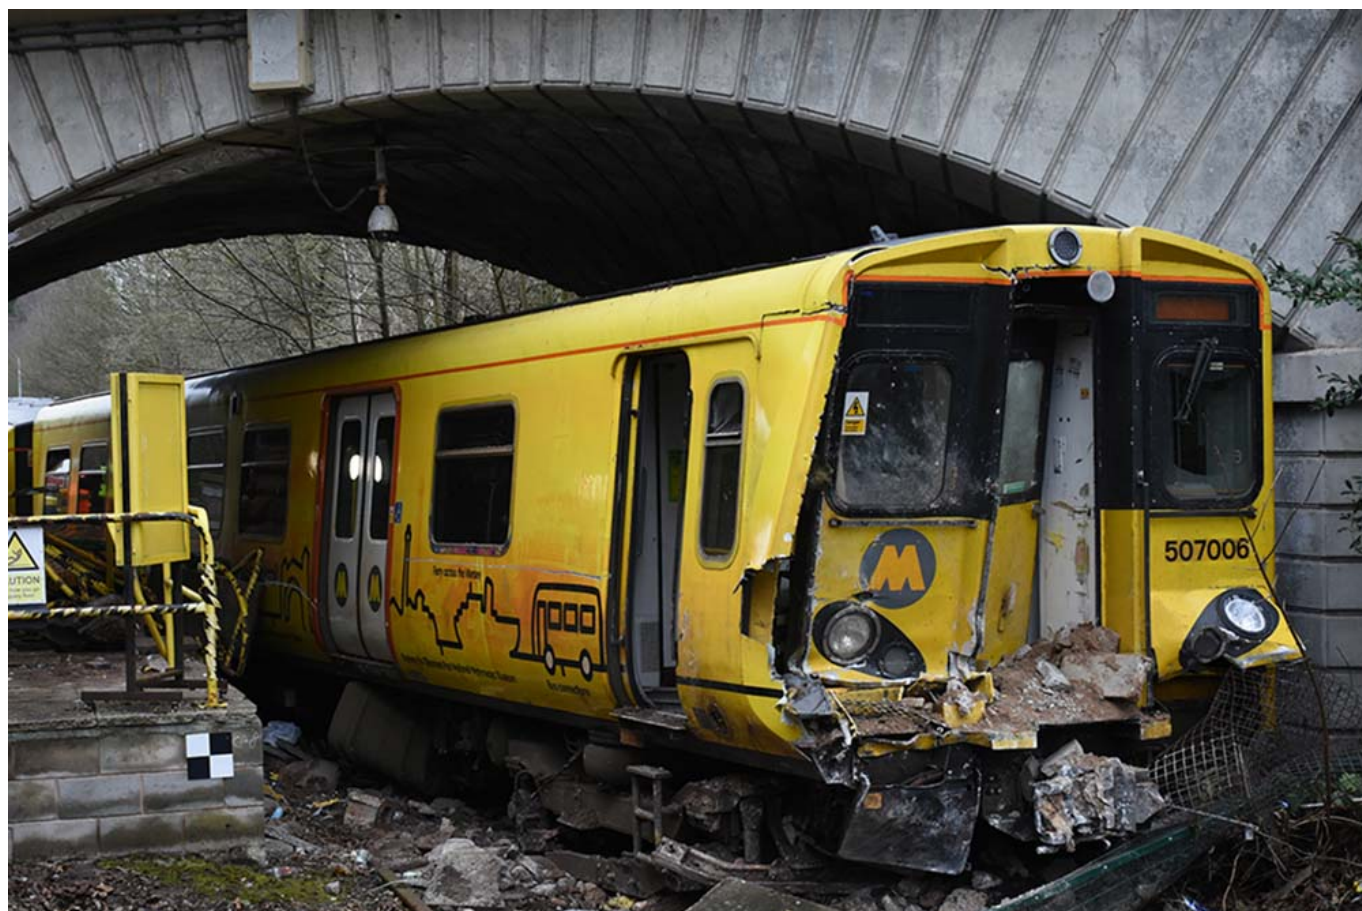
At around 18:53 hrs on Saturday 13 March 2021, a Merseyrail train hit the buffer stop at Kirkby station, Merseyside.

The train was travelling at 41 mph (66 km/h) as it entered the platform. Soon afterwards, the driver applied the emergency brake, but there was insufficient distance remaining to prevent the collision, and the train struck the buffer stop at around 29 mph (47 km/h). The train came to rest under a bridge, around 28 metres beyond the original buffer stop position. The driver was taken to hospital as a precaution and was discharged the following day. There were no other reported injuries to the guard or to the 12

passengers on board. The collision caused significant damage to the station infrastructure and the front of the train, with the station remaining closed for eight days.

RAIB points out the accident occurred because the driver of the train did not apply the brakes in time, as he was distracted from the driving task by his mobile phone and by his bag falling onto the cab floor.

RAIB has made three recommendations. The first is addressed to RSSB and relates to research into devices to monitor the alertness and awareness of drivers. The second, addressed to Merseyrail and Network Rail, seeks to improve the risk assessment process for collisions with buffer stops at terminal platforms. The final recommendation asks Merseyrail to improve its fatigue management process to follow industry good practice. RAIB also identified two learning points. The first reminds train drivers of the risks posed by using a mobile phone while driving a train. The second reminds train operating companies of the importance of understanding the limits of protection offered by the train protection and warning system when risks assessing terminal platforms.
