# Salisbury crash likely caused by “low adhesion” between wheels and track

November 3, 2021

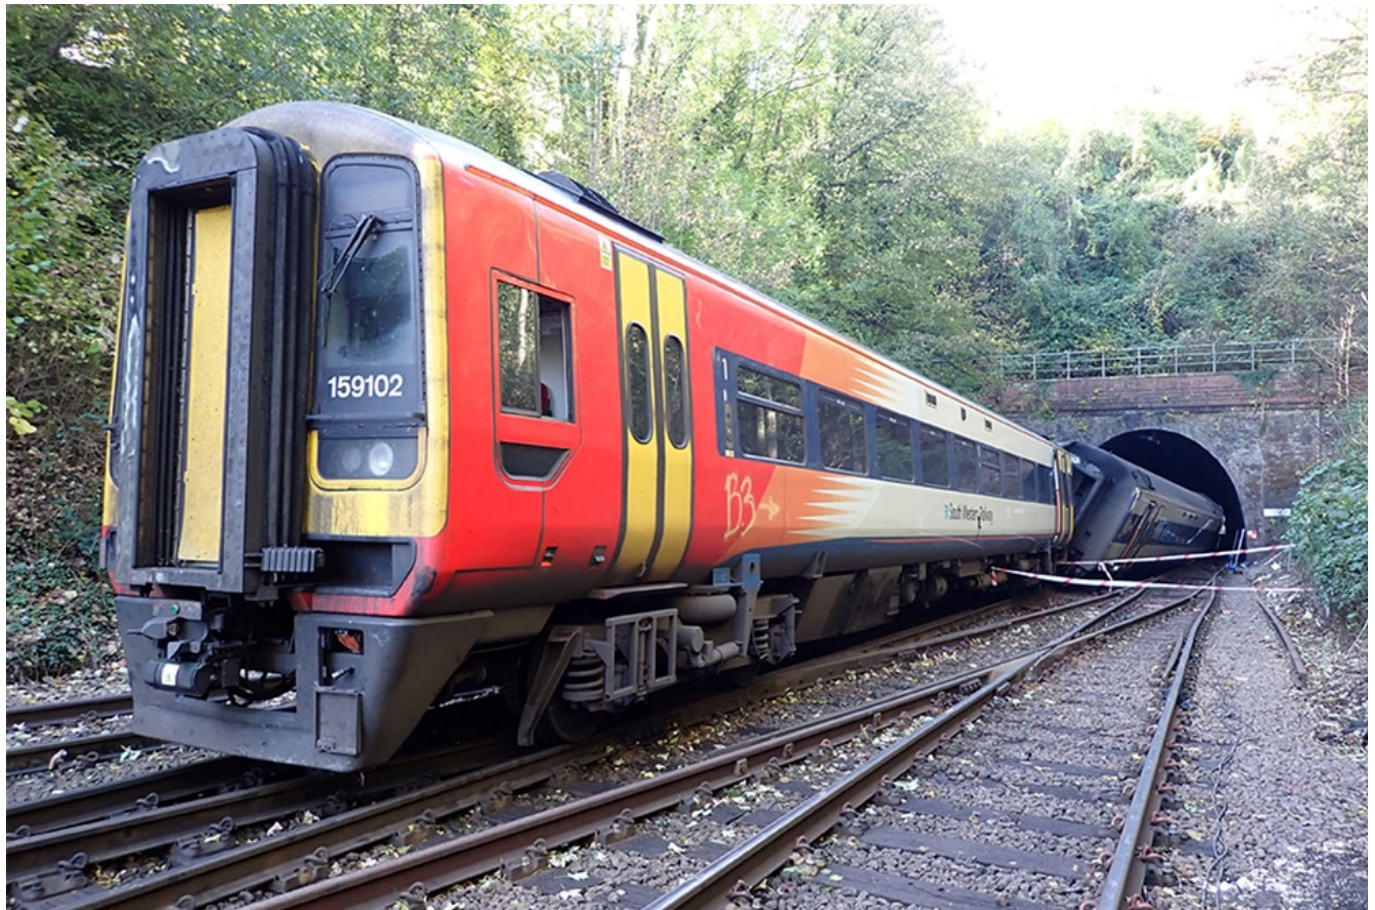
"The impact of the collision caused the front two coaches of train 1L53 and the rear two coaches of train 1F30 to derail. Both trains continued some distance into Fisherton tunnel following the collision, before they came to a stop. Thirteen passengers and one member of railway staff required treatment in hospital as a result of the accident, which also caused significant damage to the trains and railway infrastructure involved.

"RAIB's preliminary examination has found that the movement of train 1F30 across the junction was being protected from trains approaching on the Down Main line by signal SY31, which was at danger (displaying a red aspect). Train 1L53 passed this signal, while it was at danger, by around 220 metres, immediately prior to the collision occurring.

"Preliminary analysis of data downloaded from the On Train Data Recorder (OTDR) fitted to train 1L53 shows that the driver initially applied service braking to slow the train on approach to the caution signal before signal SY31. Around 12 seconds after service braking started, the driver made an emergency brake demand. As the train approached signal SY31, and with the emergency brake still being demanded by the driver, a second emergency brake demand was made by the train protection and warning system (TPWS). These emergency brake demands did not prevent the train from reaching the junction, where the collision occurred. OTDR analysis indicates that wheel slide was present both when the driver applied service braking and after emergency braking was demanded. This was almost certainly a result of low adhesion between the train's wheels and the rails."
