# Helicopter surveys keep Wolverhampton and Tamworth stations' big freezes at bay

January 26, 2021

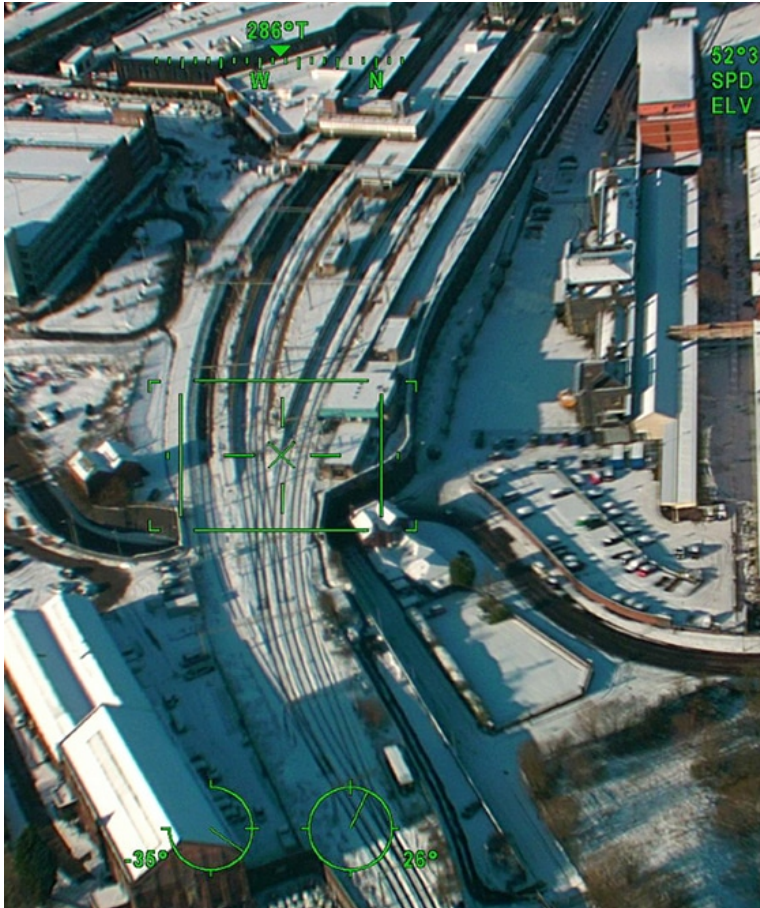
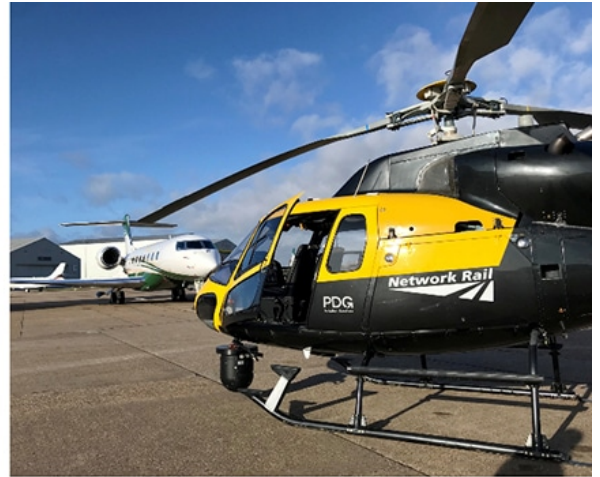
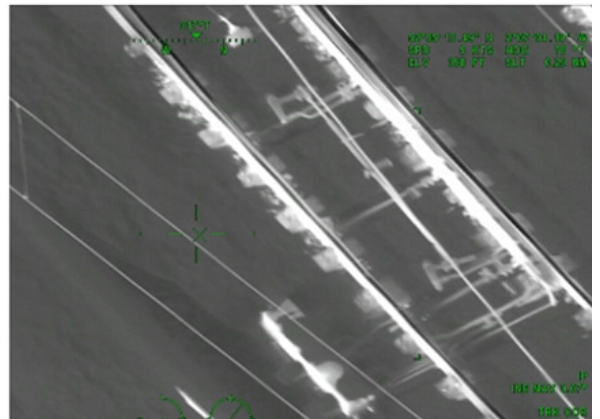
The impressive aerial photos taken on the flight over Wolverhampton station, and also Tamworth station in Staffordshire, are to check that points – the equipment which allows trains to move tracks – do not become frozen and stop working.

In each set of points the steel rails are heated to stop this from happening. If the heaters are working properly the points should glow bright white in the thermal pictures – if they appear dark the helicopter team raises the alarm to engineers on the ground for them to fix.

"Anything reported to us from the skies can then be looked at straight away by the extra teams of people on the ground and fixed as quickly as possible."
