Helicopter surveys keep Wolverhampton and Tamworth stations' big freezes at bay

January 26, 2021

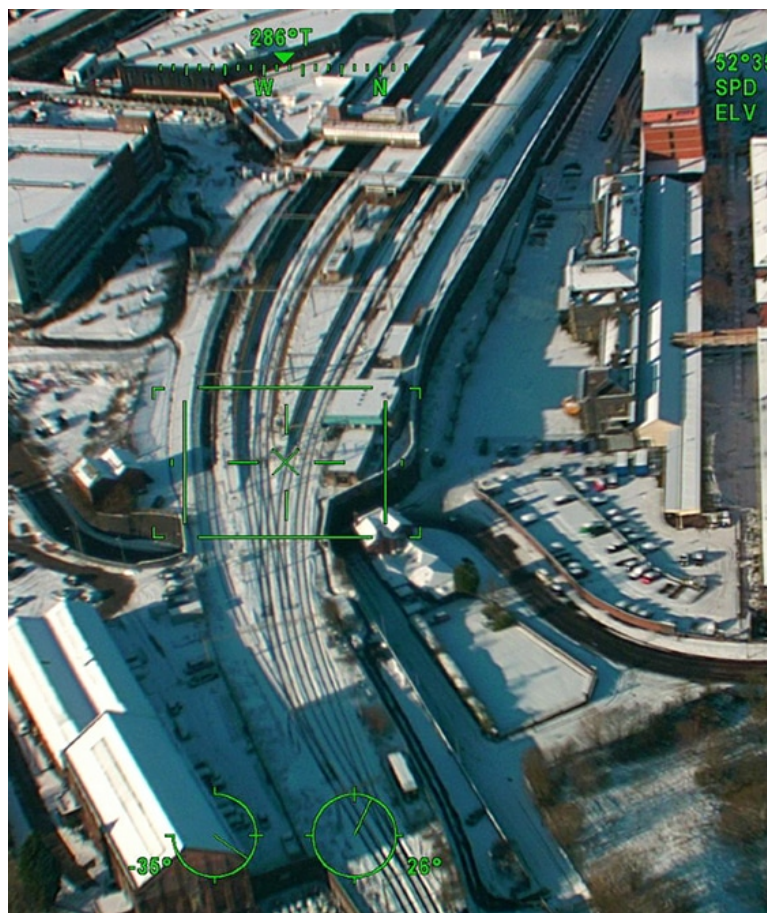
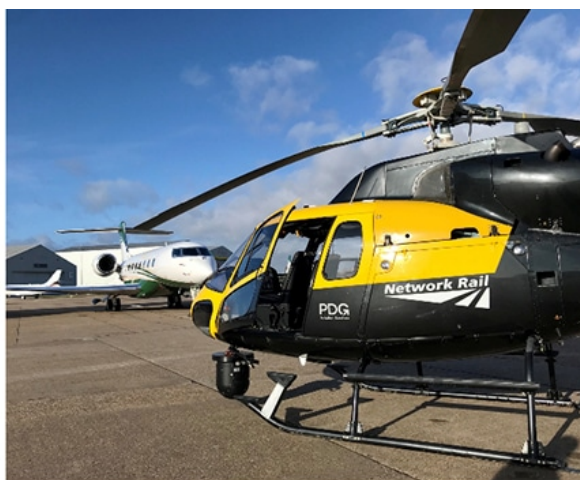
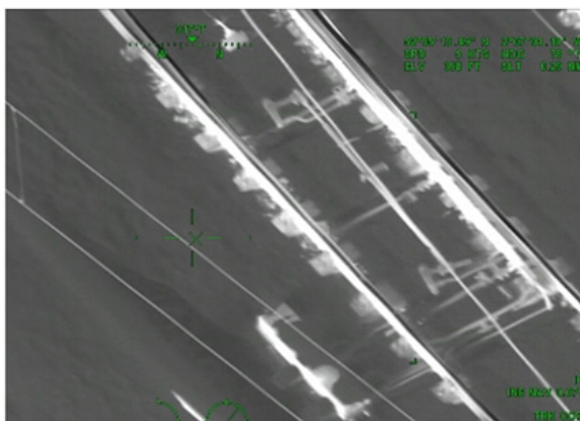
The impressive aerial photos taken on the flight over Wolverhampton station, and also Tamworth station in Staffordshire, are to check that points – the equipment which allows trains to move tracks – do not become frozen and stop working.

In each set of points the steel rails are heated to stop this from happening. If the heaters are working properly the points should glow bright white in the thermal pictures – if they appear dark the helicopter team raises the alarm to engineers on the ground for them to fix.
