Runaway and derailment of wagons at Toton

January 29, 2021

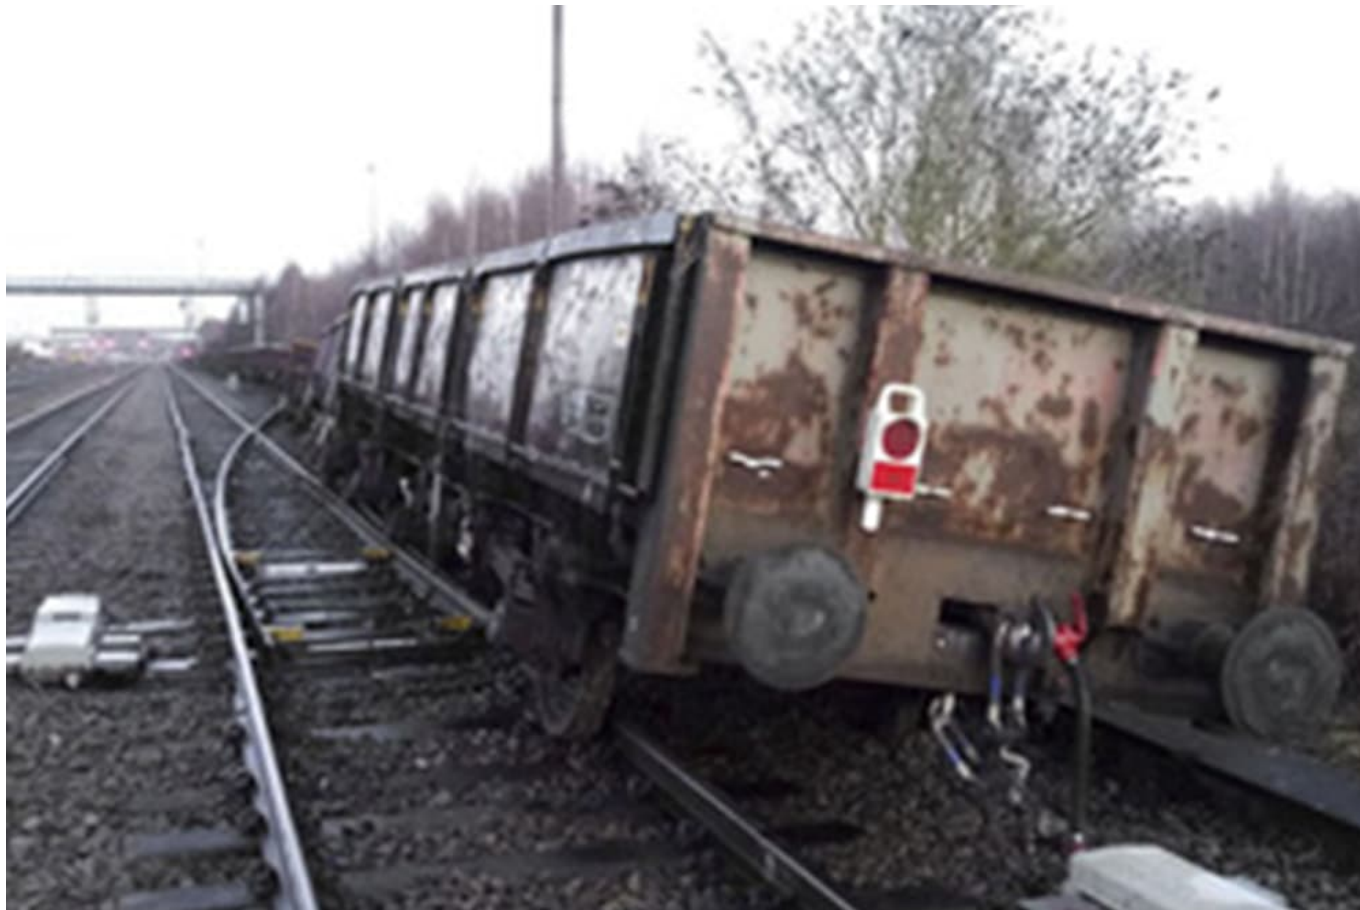
“The rake then passed a second red signal and, a short distance later, the leading four wagons derailed at the end of the run-out rails associated with a set of trap points at Toton South junction. The trap points worked as intended to derail the unauthorised movement. However, the front two derailed wagons stopped foul of the adjacent running line, although no trains were nearby when the derailment occurred. The rake of wagons ran away for a total distance of about 0.5 miles (0.8 km).
