# Stonehaven-Montrose railway set to reopen for customers

February 17, 2021

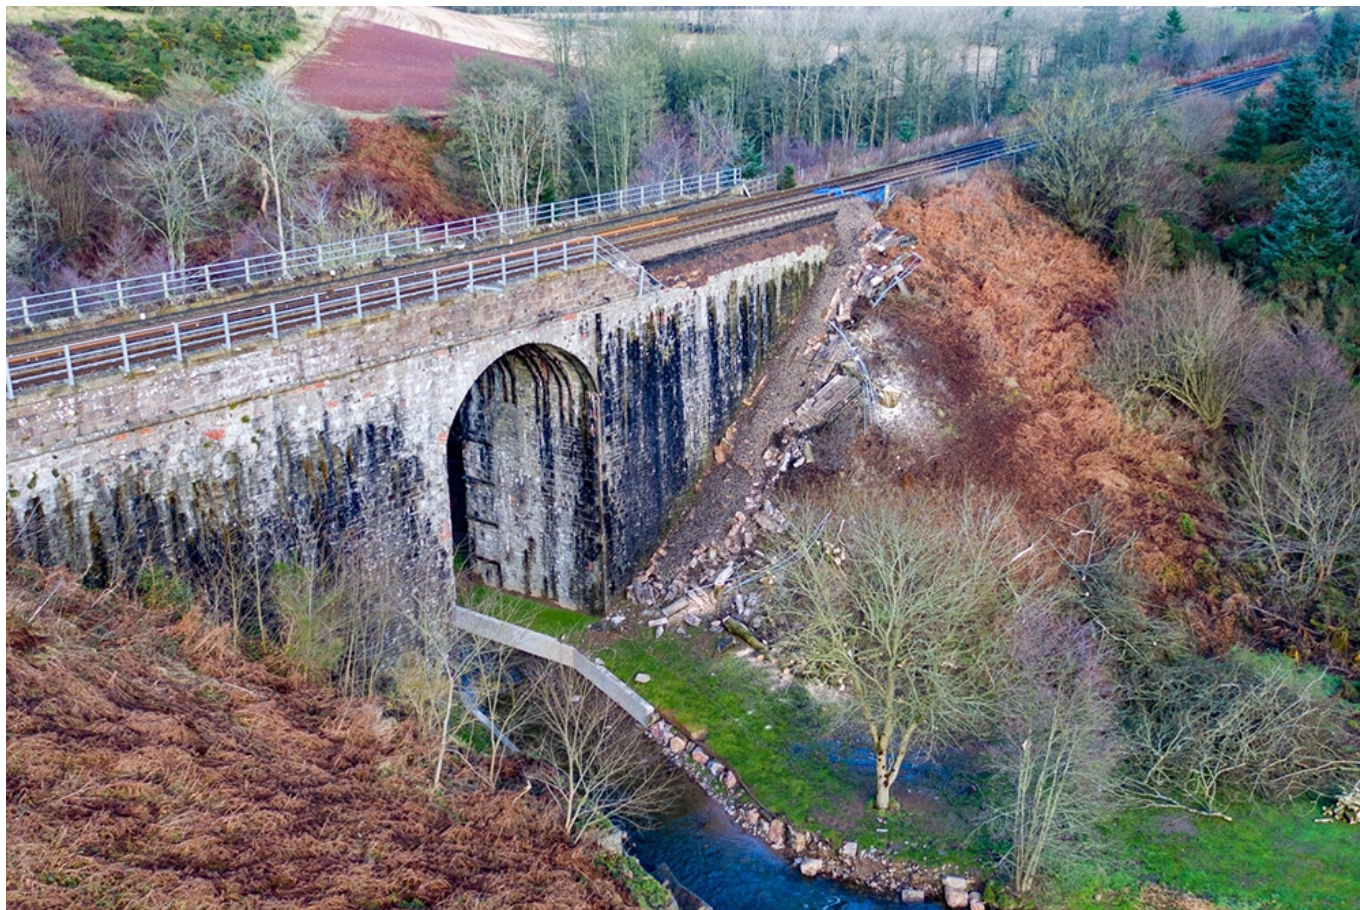
The rail bridge – which dates from the 1840s and is located three miles north of Carmont – has been closed since January 15 after masonry fell from the sidewall (parapet) on the southbound side of the structure.

- Installing additional concrete supports on the bridge deck to help retain and support the track and ballast.
- Reconstructing the failed parapet wall.
- Installing ties through the bridge to strengthen the overall structure.
- Relaying new track and supporting ballast on the southbound side on the bridge.
